**USAAVLABS TECHNICAL REPORT 65-64**

**TEST PROGRAM  
FOR  
AUTOMATIC LIGHT AIRCRAFT READINESS MONITOR**

**(Project ALARM)  
FINAL REPORT**

**U. S. ARMY AVIATION MATERIEL LABORATORIES  
FORT EUSTIS, VIRGINIA**

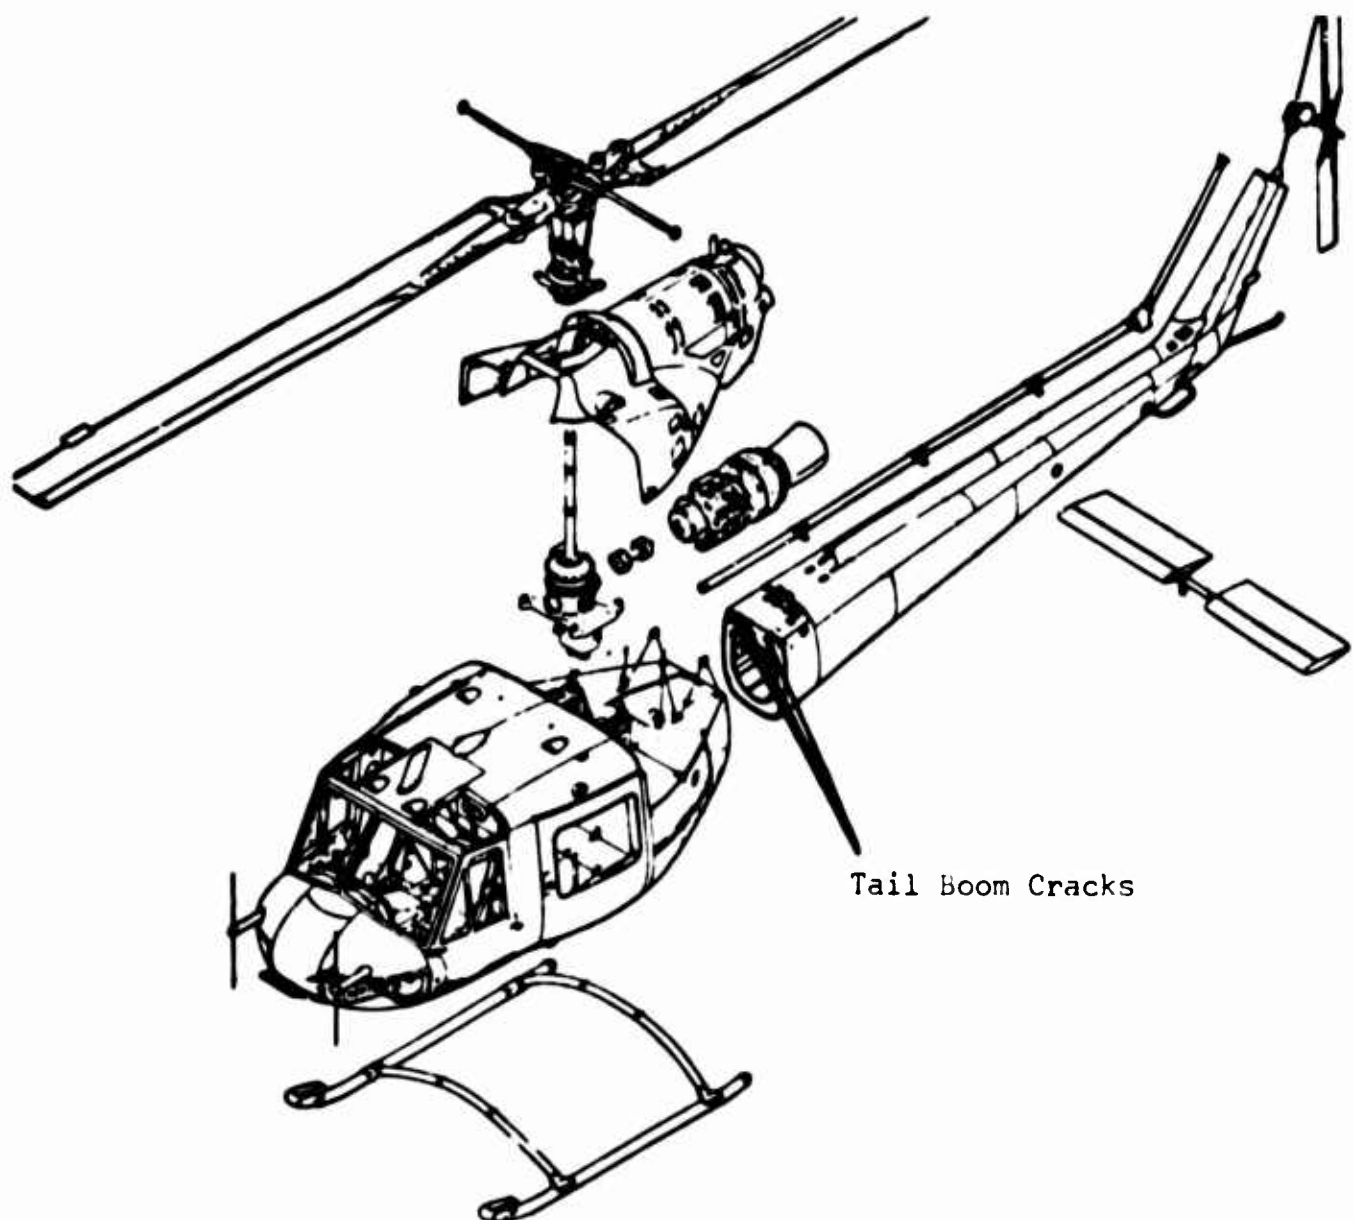
The cracks in the tail boom were discovered during a detailed inspection that was initiated because of the unusually high ALARM tail vibration readings. The locations of these cracks are shown in Figure 3. These cracks were not detected by conventional maintenance methods, and, had the unusually high ALARM vibration indications not occurred, the detailed inspection would not have been made.

Figure 3. Tail Boom Cracks From Vibration.

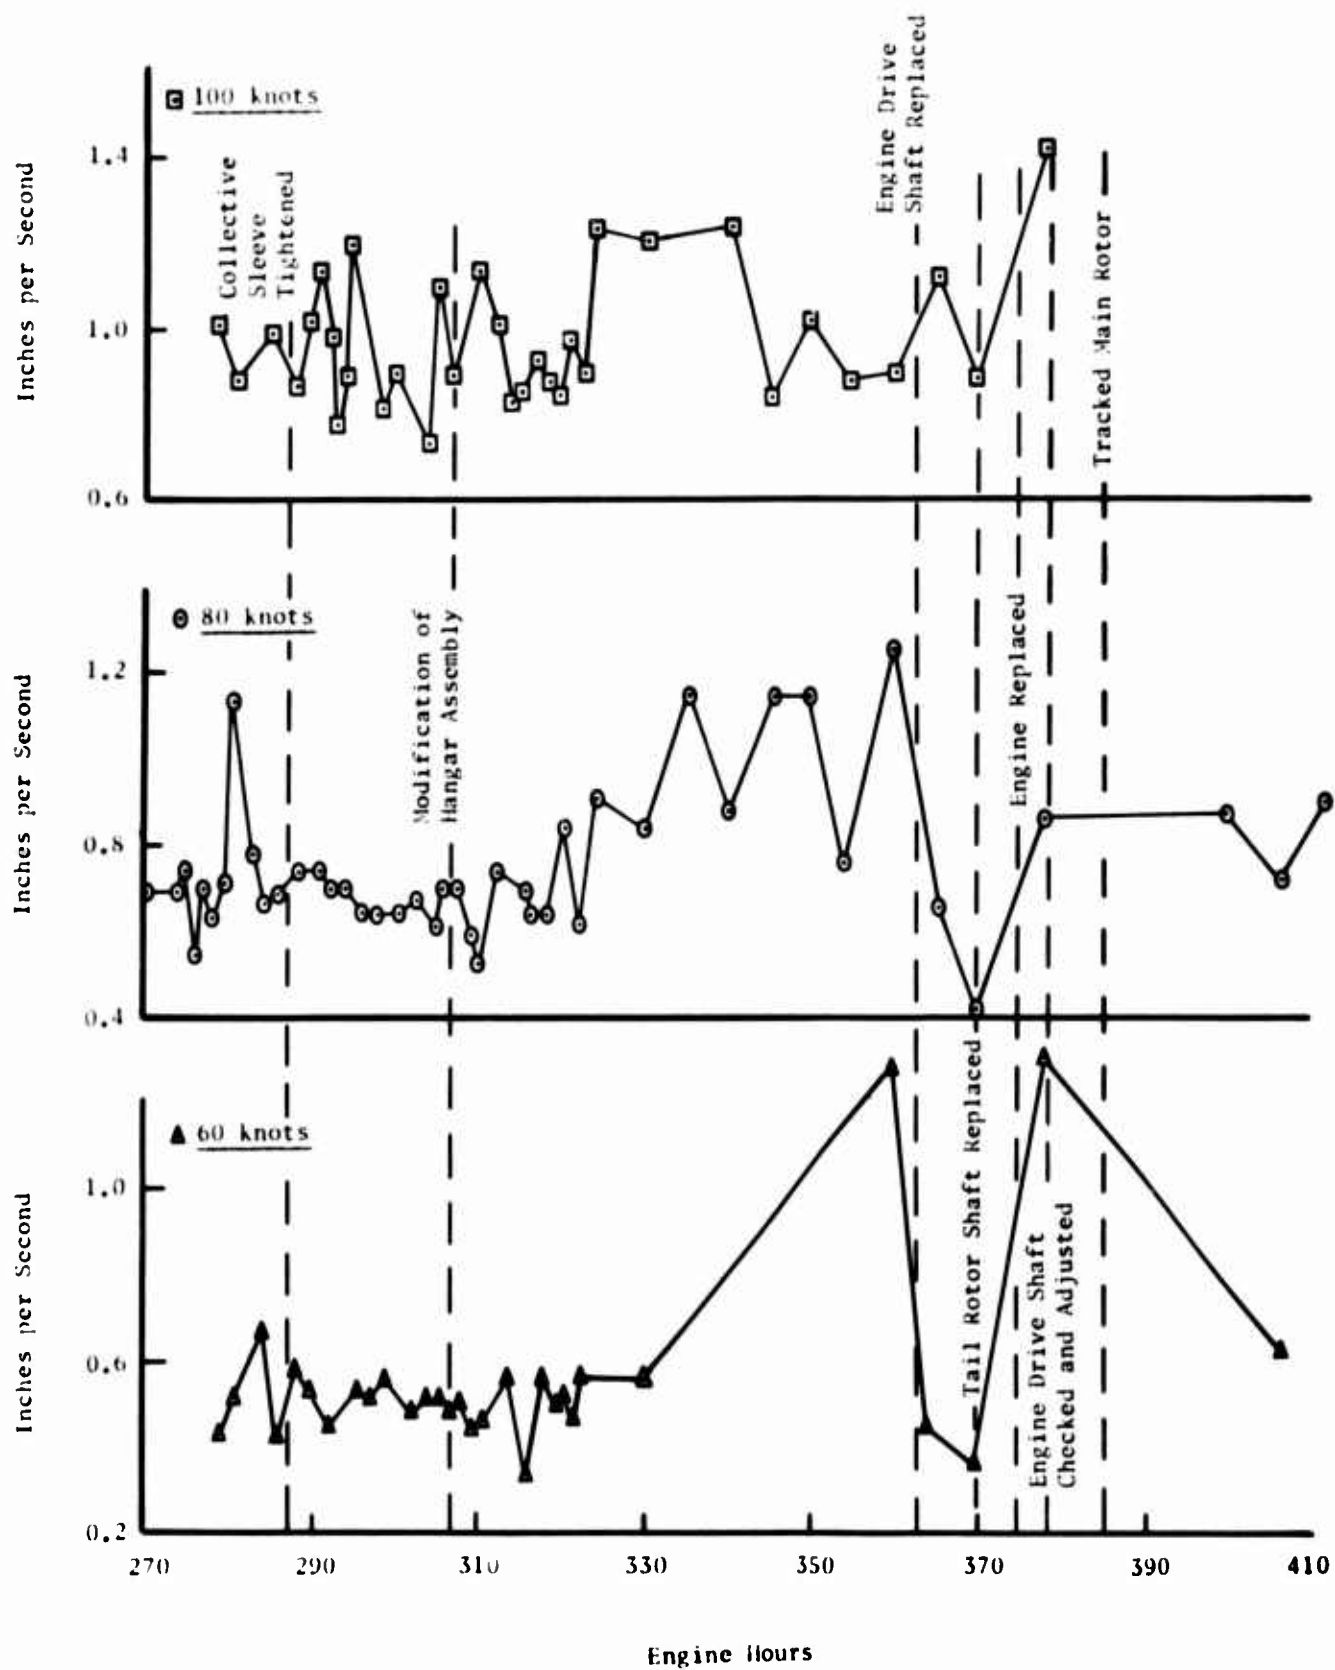
During some test flights, many readings were omitted because of lack of time; thus, large gaps were left between some readings. An example of this can be seen in Figure 4 (page 18) for the 60-knot plot between engine hours 330 and 370. In such cases, the line joining the two points cannot be considered as representative of the actual vibration level and is only included for continuity.

The low frequency plots (Figure 4) for 80 knots and 60 knots indicate that there was a steady increase in the vibration level until the engine drive shaft was replaced at 363 engine hours, at which point the vibration level decreased sharply. Upon replacement of the engine, at 375 engine hours, the vibration level increased sharply. At 377 engine hours, the main rotor was tracked and the drive shaft was adjusted; the vibration level then dropped to the normal operation level.

Figure 4. Low Frequency Vibration (3 to 100 cps).

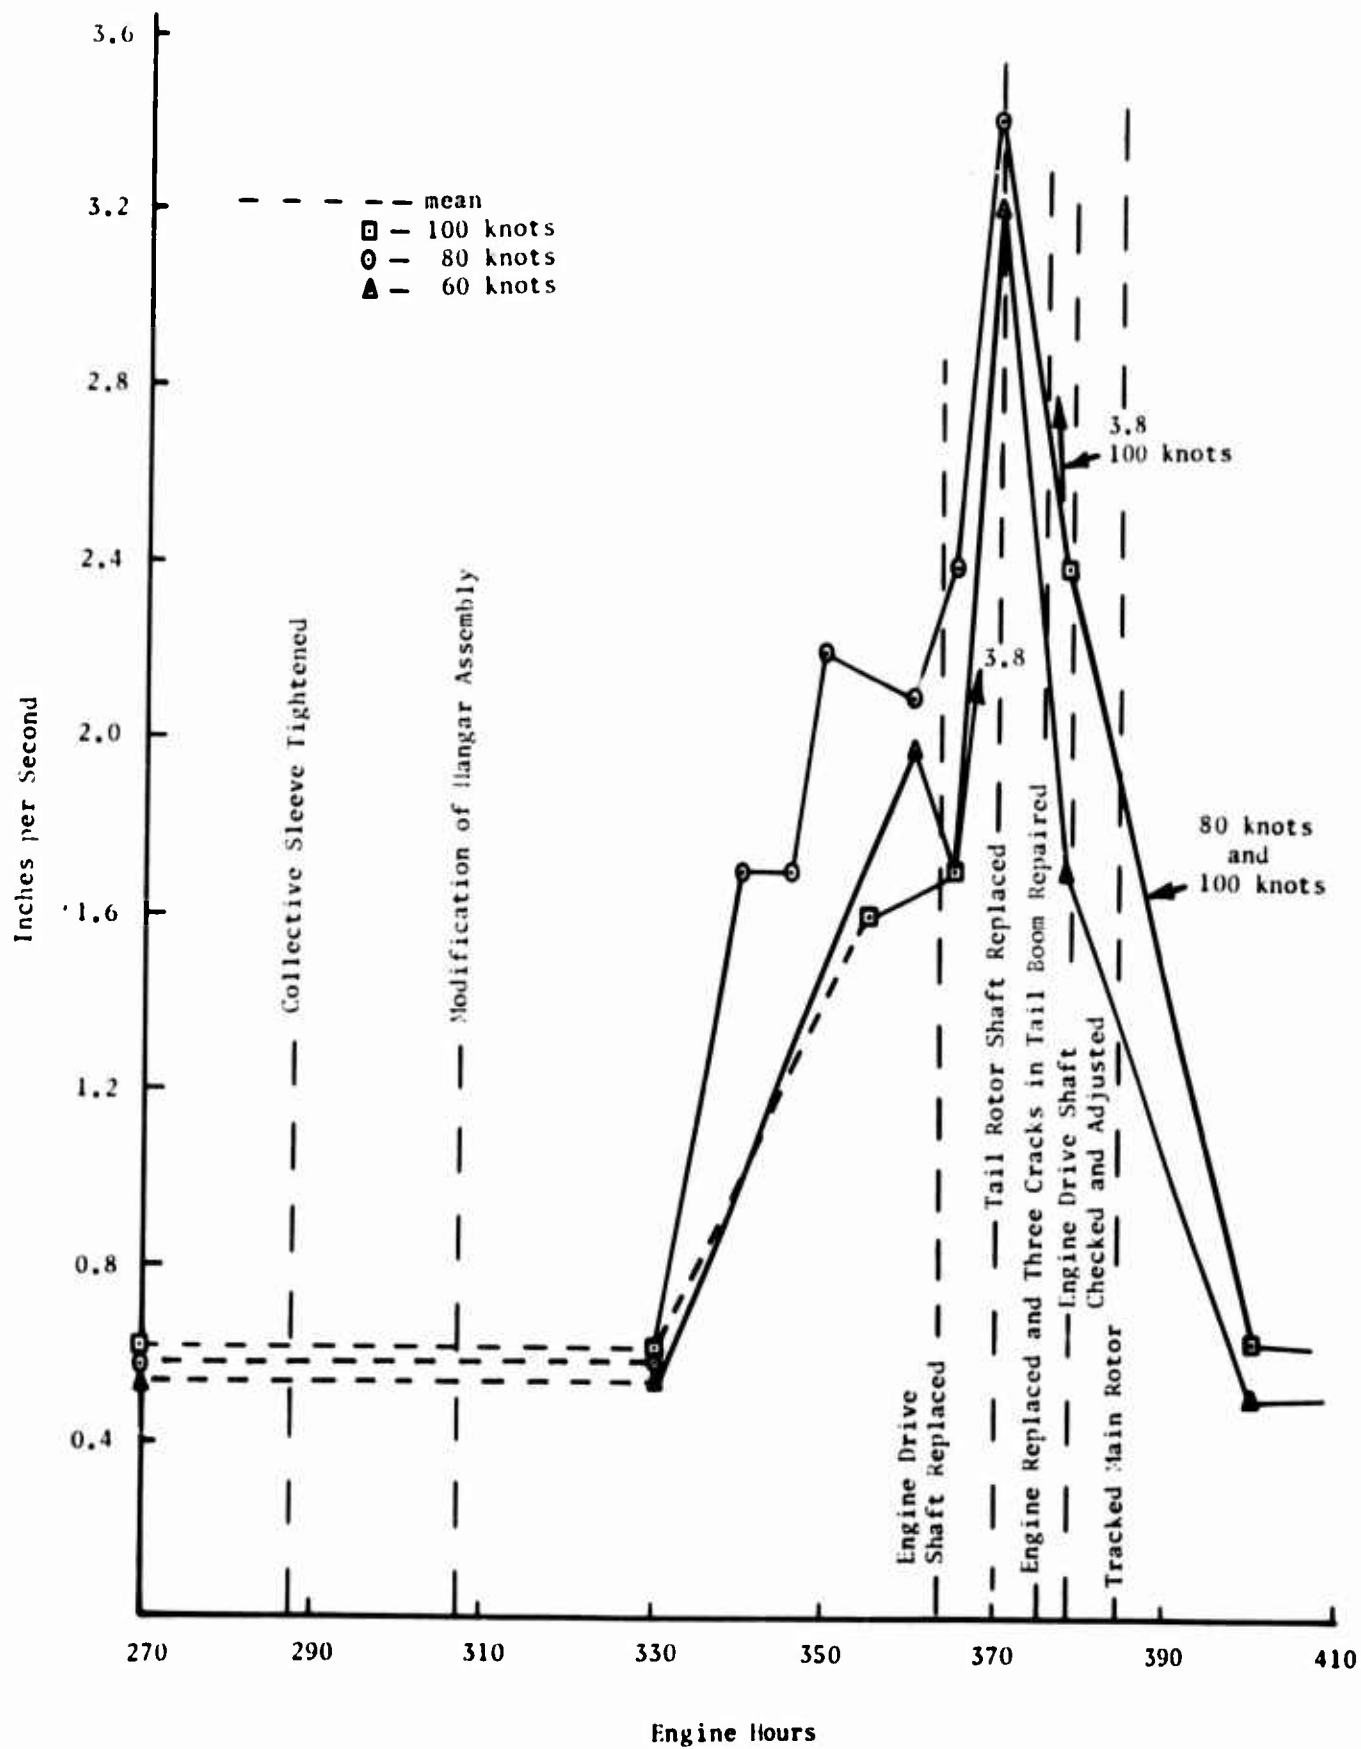
Figures 5 through 9 display the vibration levels of various components of the aircraft versus engine hours. Superimposed on each of these graphs are descriptions of the major repairs performed on the aircraft during the test period. Each of the vibration levels recorded was taken through a frequency band wide enough to include all significant vibrations of the respective component. Most noteworthy of the vibration plots is that of the tail vibration, Figure 5, which displays a climb in the vibration level beginning at 330 engine hours. The climb continued to the 370-engine-hour reading; then, a bent tail rotor shaft and three cracks in the tail boom were repaired and the engine was replaced. The vibration level took a substantial drop immediately following these repairs; however, it did not drop to the normal operating level until the engine drive shaft was adjusted at 377 engine hours and the main rotor was tracked at 385 engine hours.

Figure 5. Tail Vibration (20 to 2,000 cps).

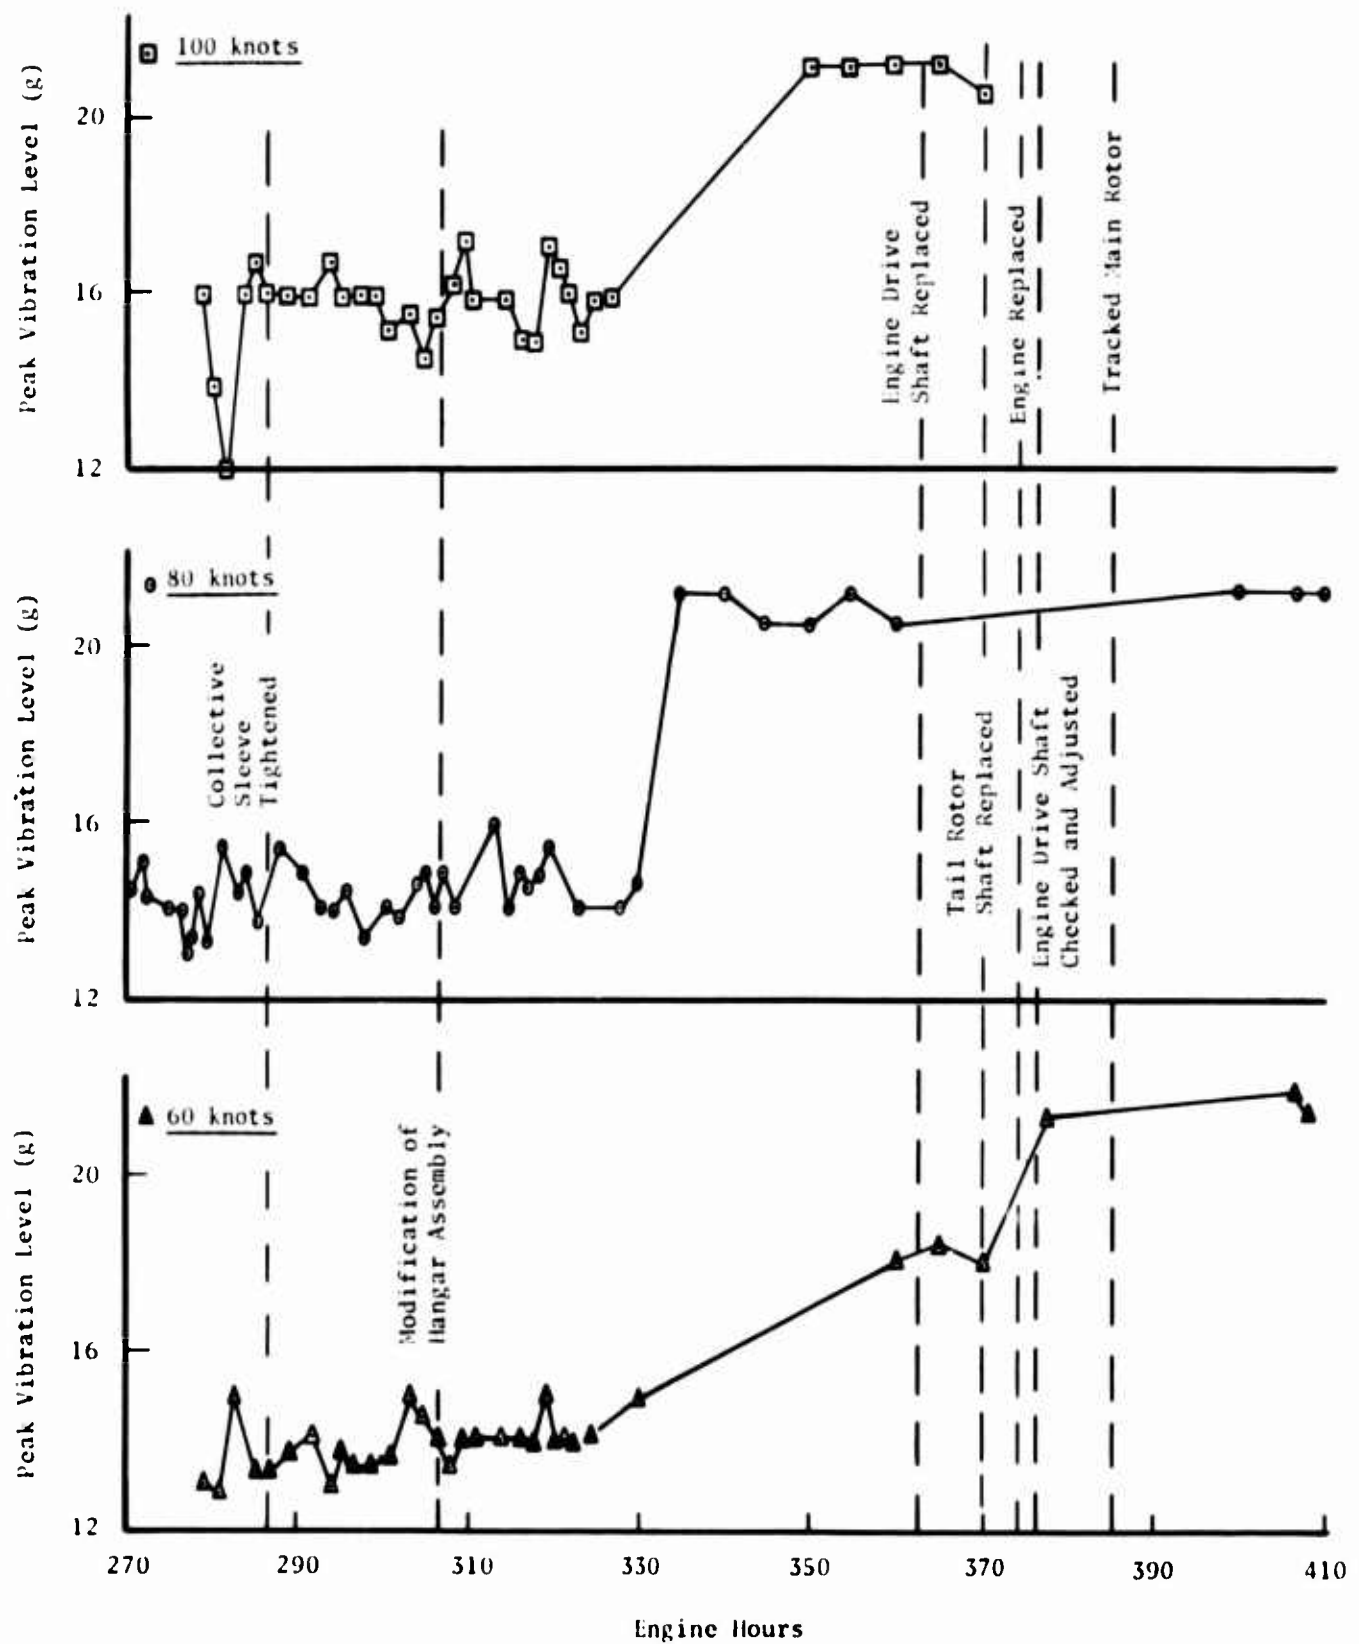
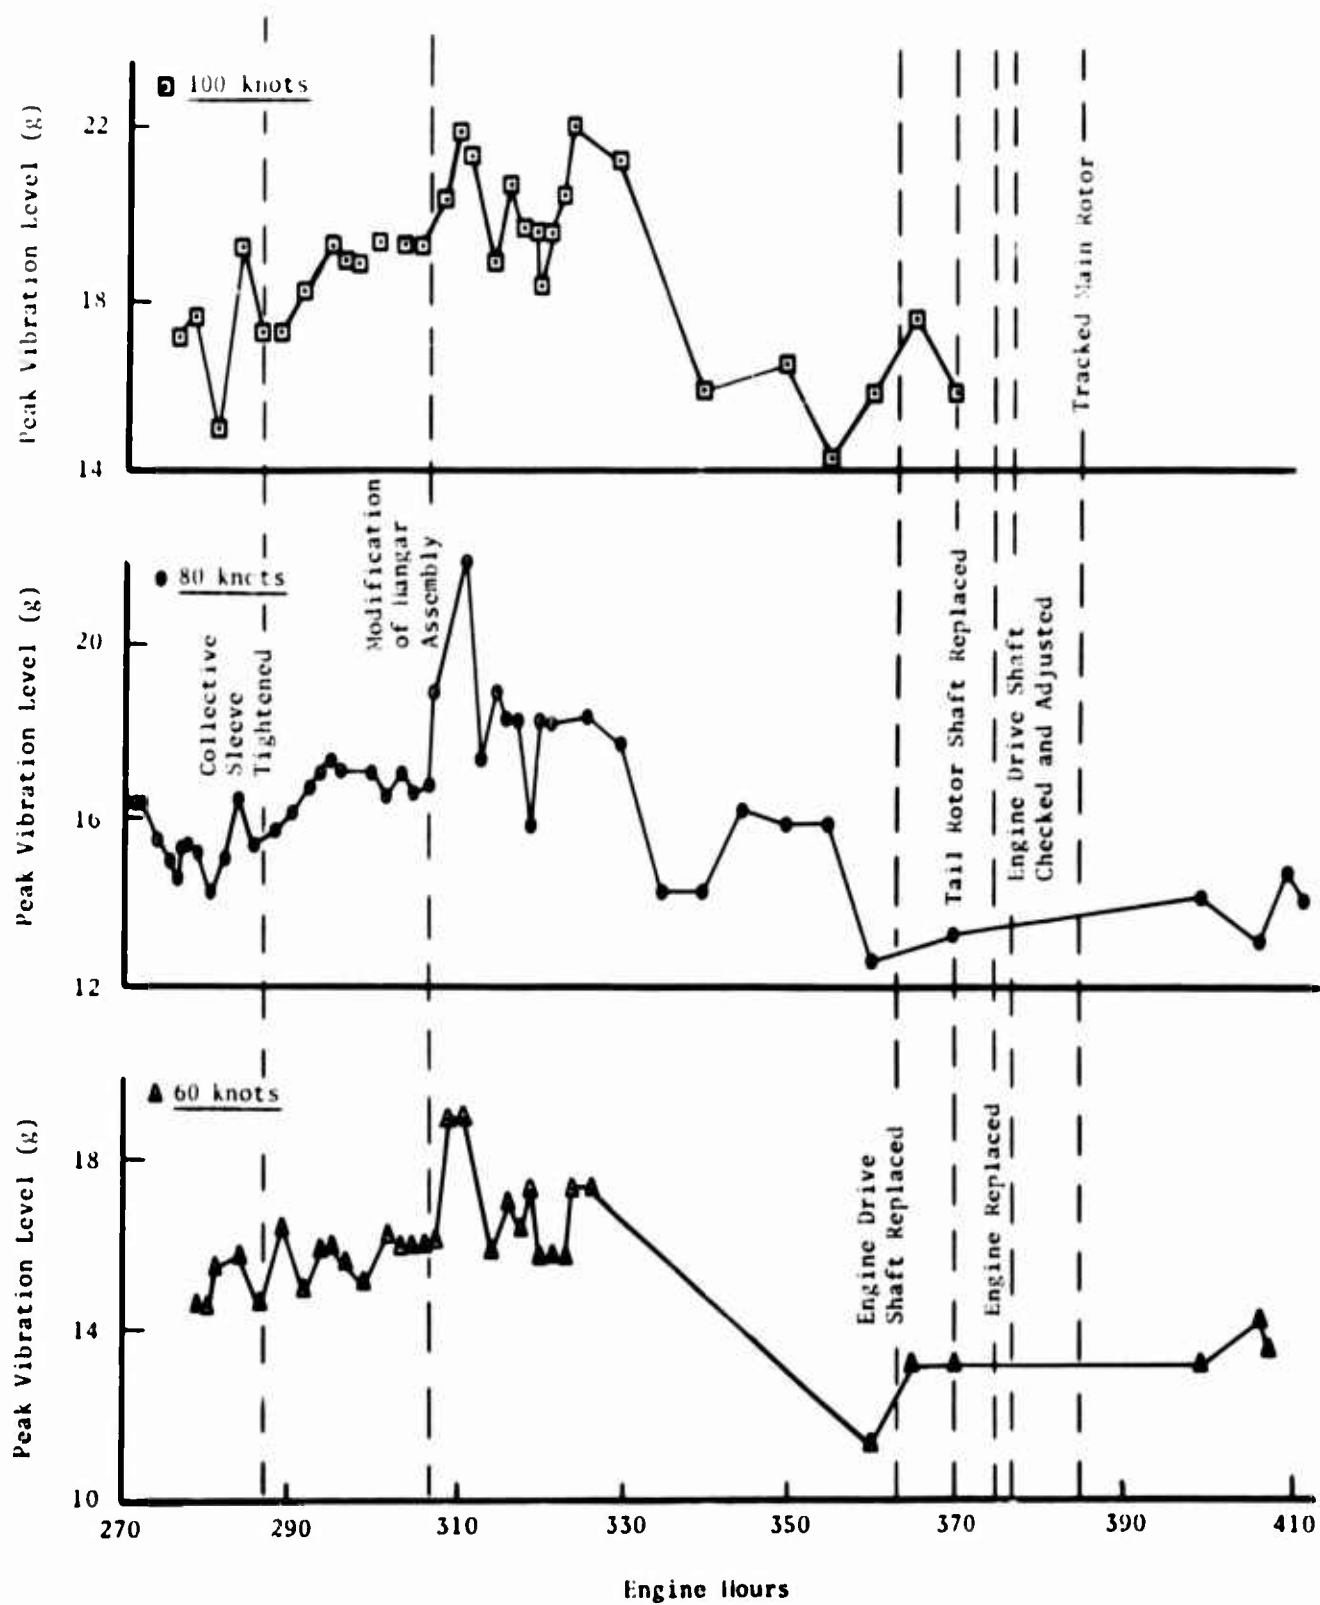
An interesting feature displayed by the transmission plots, Figures 6 and 7, is that at 330 engine hours the vibration level of the transmission top began to decrease and that of the transmission base to increase. These trends continued until the end of the test period, although no explanation presented itself for these phenomena.

Figure 6. Transmission Base Vibration (500 to 20,000 cps).

Figure 7. Transmission Top Vibration (500 to 20,000 cps).

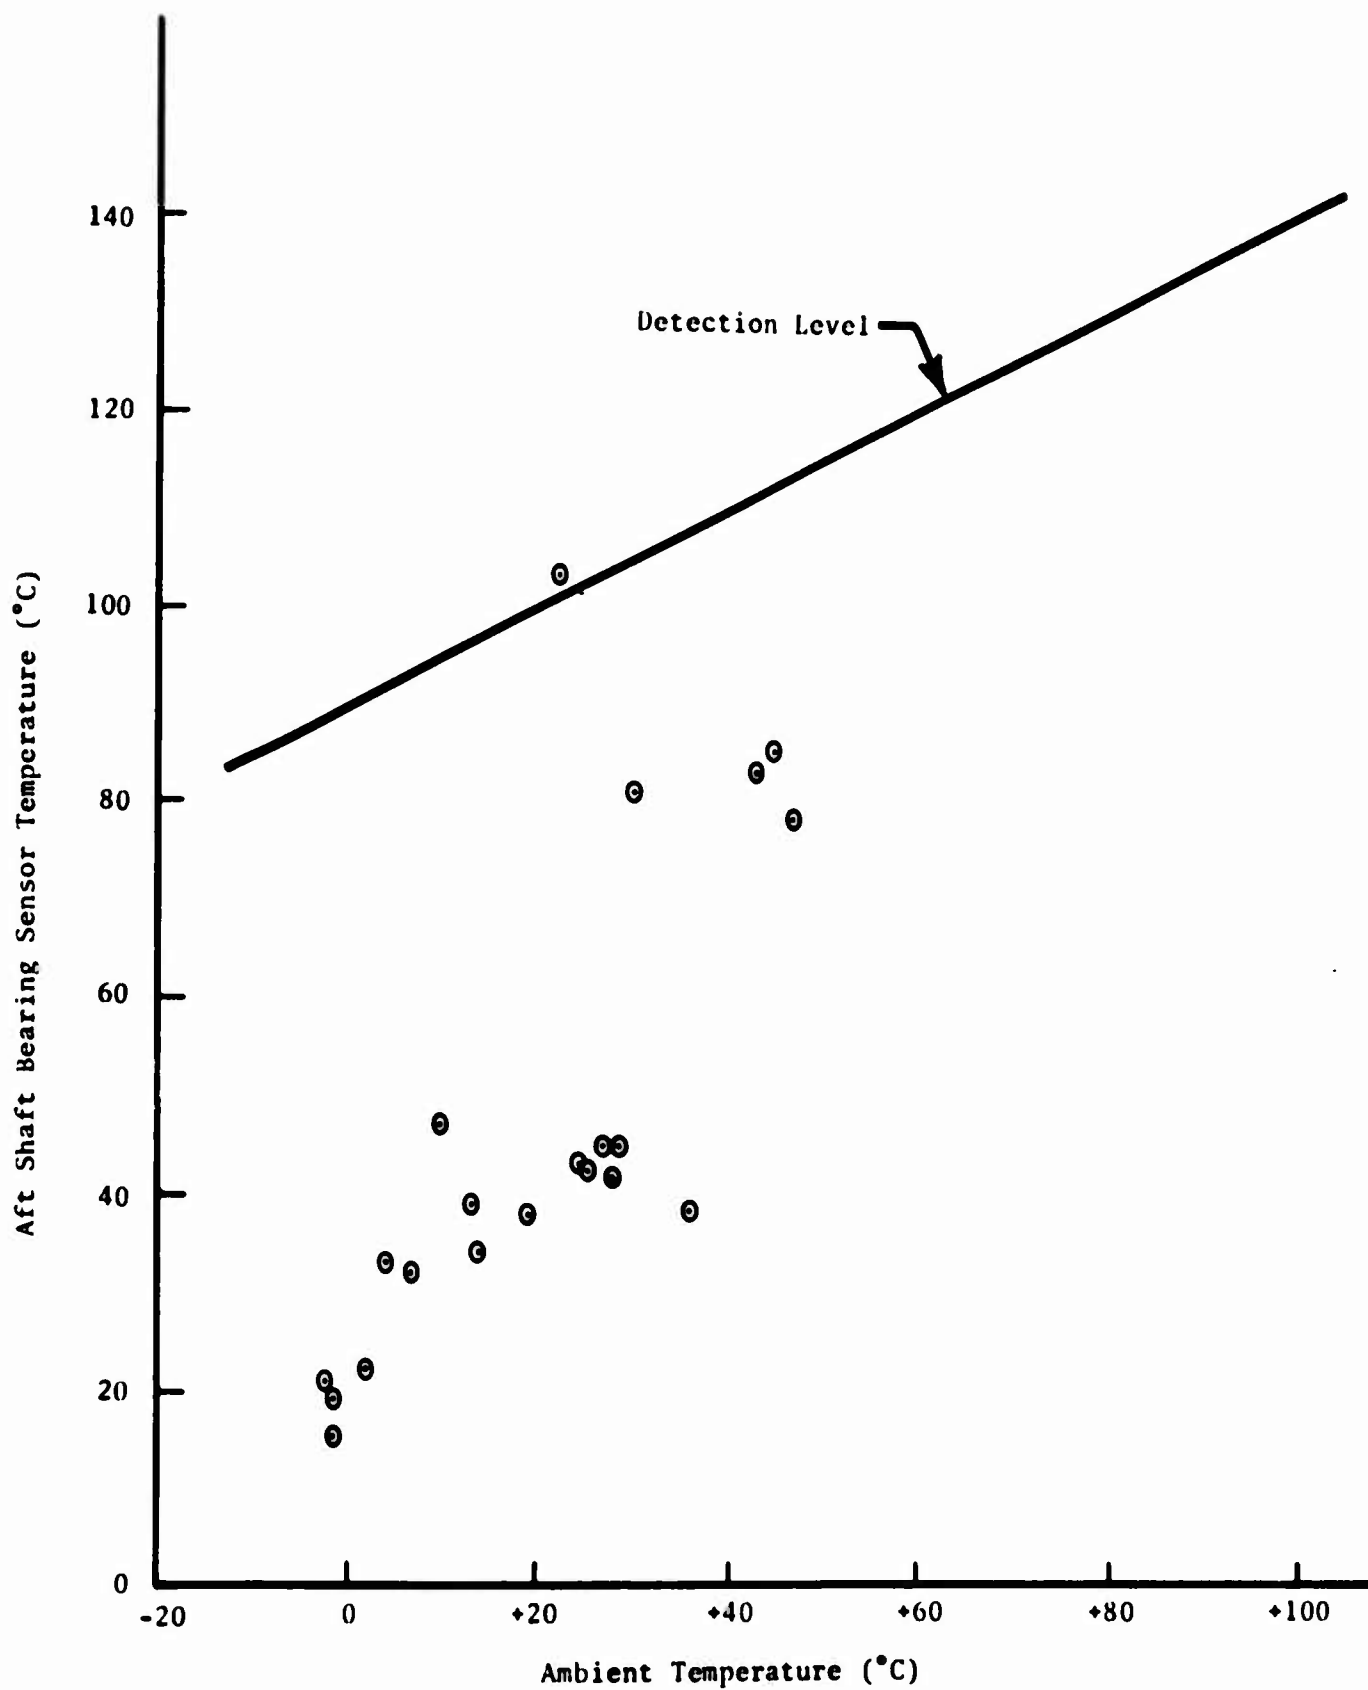
Three no-go indications were obtained during the dynamic and flight tests. One was sensed by the aft shaft bearing sensor (see Figure 12) and two were sensed by the swash plate bearing sensor (see Figure 13).

In all three of these instances, it was determined that the bearings yielding the no-go readings were contaminated. Upon removing, purging, and re-installing the bearings, the respective sensors gave normal operating readings.

Figure 12. Aft Shaft Bearing Sensor Temperature Versus Ambient Temperature.

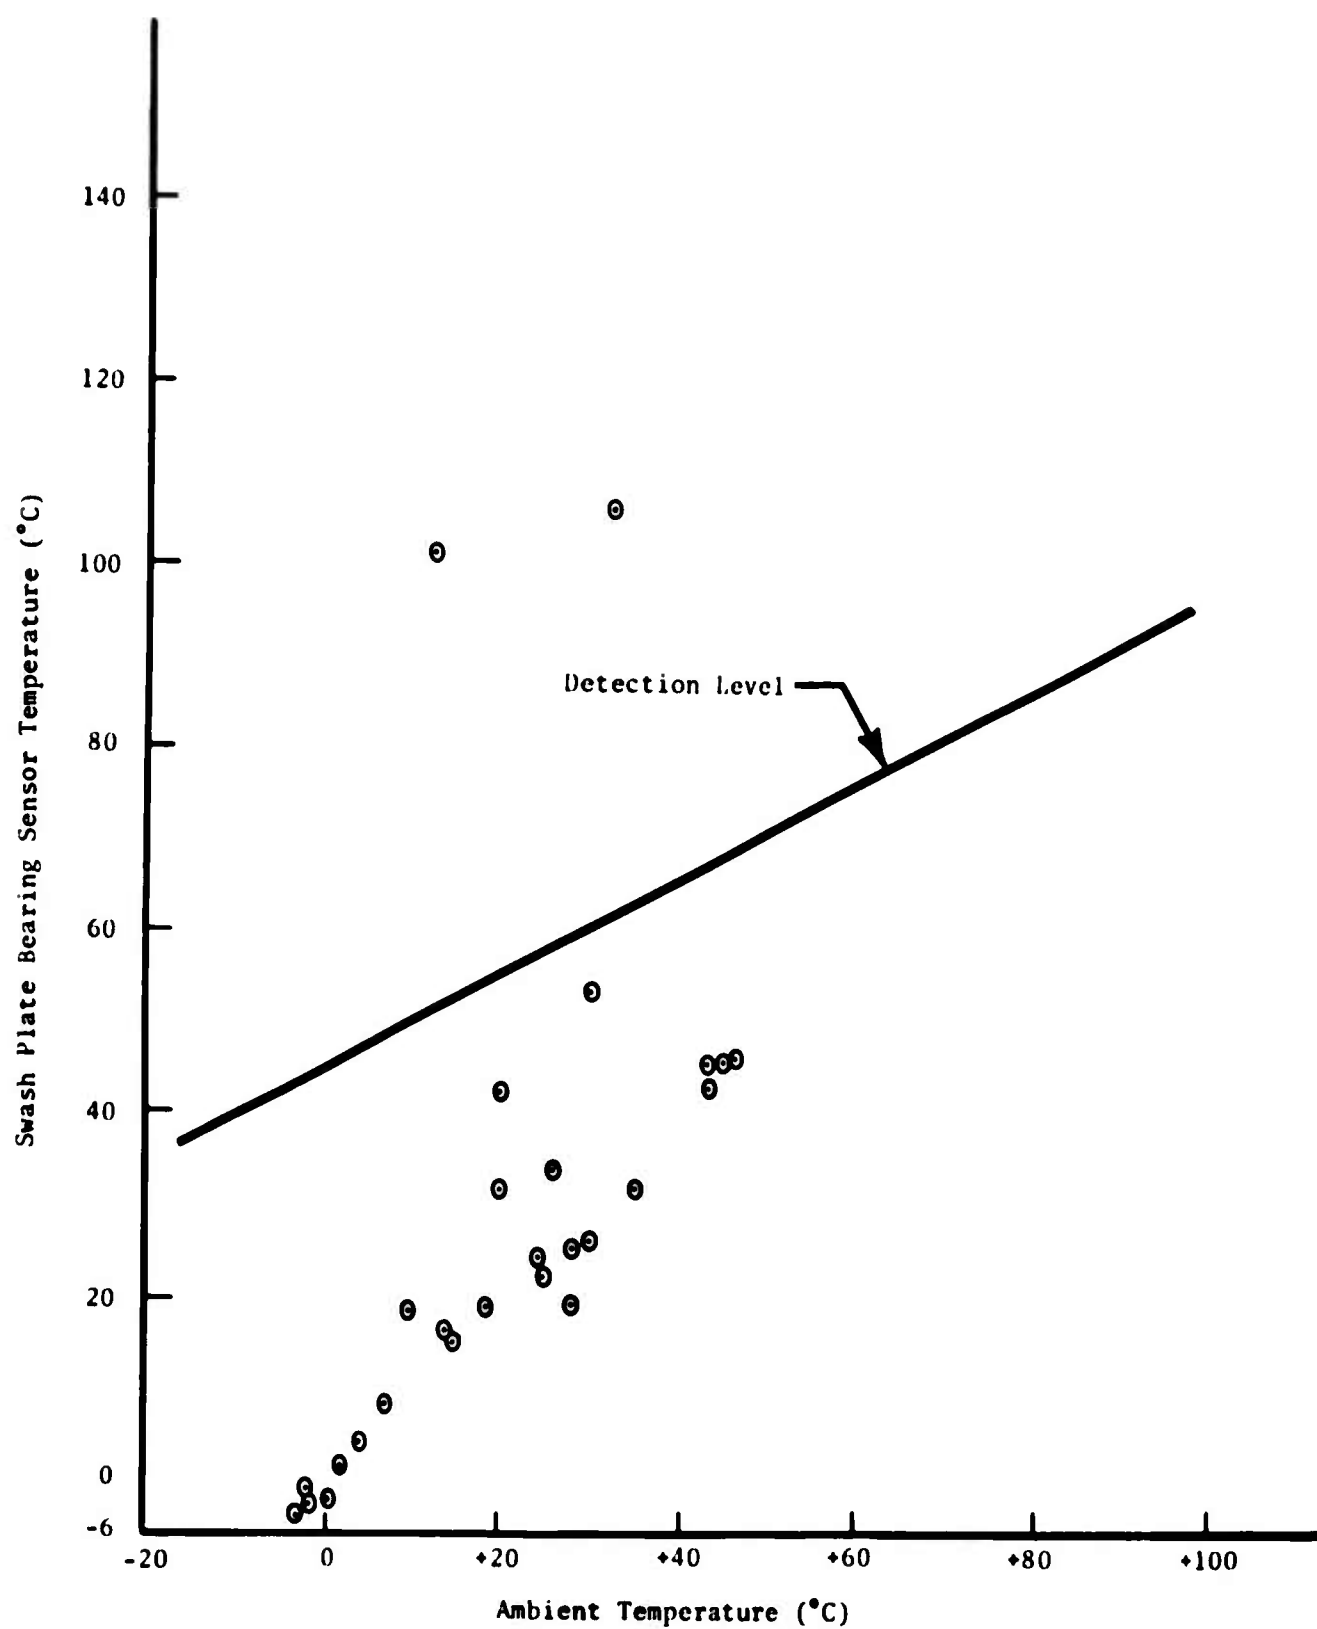
Figure 13. Swash Plate Bearing Sensor Temperature Versus Ambient Temperature.
